# Rupture of Subcutaneous Peritoneal Dialysis Catheter by Stretching Exercise: A Case Report

*Rupture of the peritoneal dialysis (PD) catheter is rare complication. Here, we report a case of catheter rupture that occurred because of exercise after partial catheter reimplantation.*

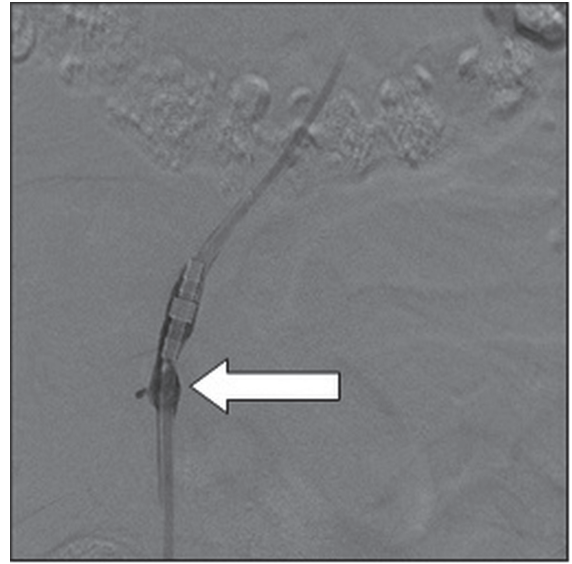
The patient was discharged on postoperative day 3. However, he was readmitted 5 days later because of a leak of dialysate from the presternal exit site. On admission, he was not complaining of abdominal pain. No trauma to the subcutaneous catheter had occurred. In addition, swelling and redness were not observed at the subcutaneous tunnel. Fluoroscopy performed to investigate the cause of the pericatheter leak demonstrated leakage from the area at which the titanium extender and the catheter connected (Figure 1). Surgery to repair the leak was performed.

FIGURE 1 Leakage at the point at which the titanium extender and the extended peritoneal dialysis catheter meet (arrow) was confirmed by fluoroscopy.

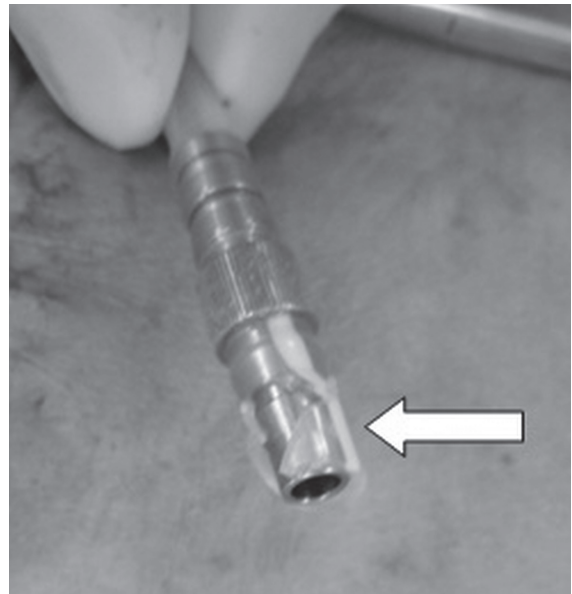
Initially, we thought that the cause of the leak was detachment of the titanium extender from the catheter. However, we found that the PD catheter had ruptured at the site of the leak (Figure 2). We believed that the cause of the rupture was mechanical stress induced by the patient's stretching exercise program (dorsiflexion of the trunk). We removed the remaining part of the catheter and created a new exit site in the upper abdomen by connecting a new catheter. Since then, the patient has been undergoing regular PD without pericatheter leakage.

FIGURE 2 Rupture between the titanium extender and the peritoneal dialysis catheter (arrow).

We experienced a rare case of subcutaneous rupture of a PD catheter by exercise. In our opinion, to avoid PD catheter rupture, clinicians should discourage excessive stretching for patients whose catheter exit site is changed from an abdominal to presternal position during partial reimplantation.
